Housing as a Determinant of Tongan Children's Health: Innovative Methodology Using Wearable Cameras

Keywords: Tonga; housing; children; health impact

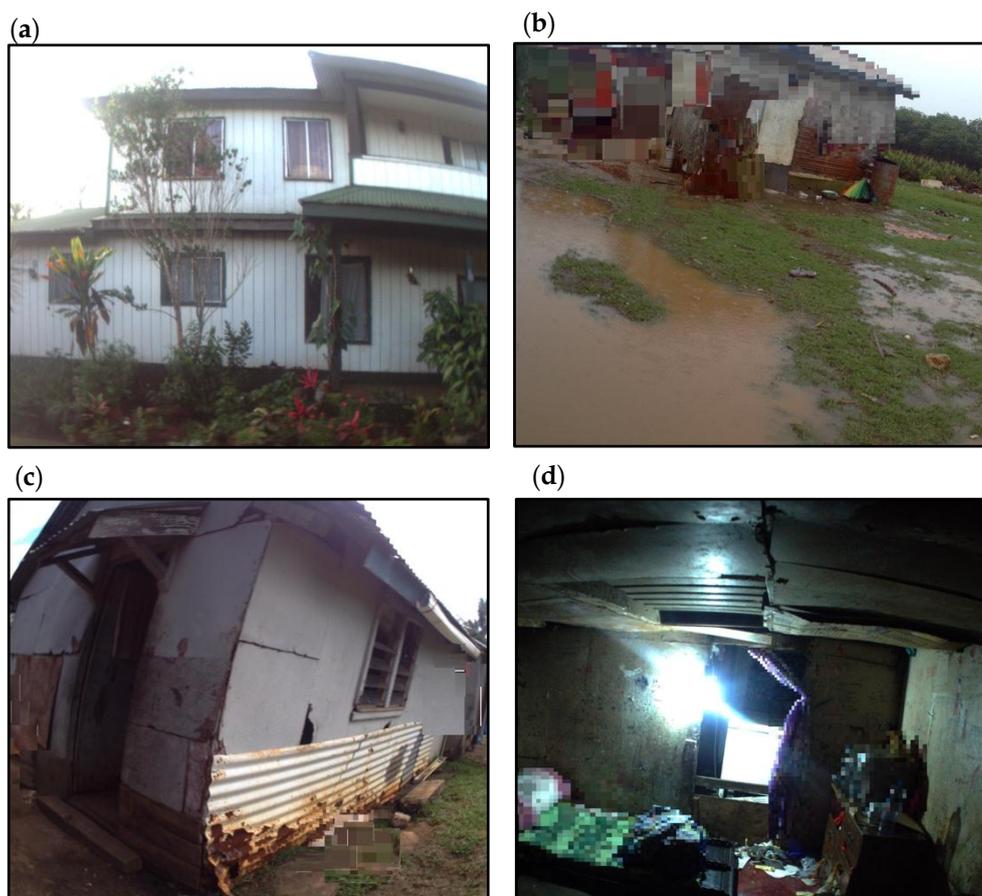
Over a quarter of the houses had no evidence of structural damage or water permeation into the home (Figure 1a). Eleven houses (15%) had significant and extensive structural damage, which could present a significant risk to the health of the occupants (Table 1). These houses did not appear structurally secure or weather tight, and would not provide adequate shelter from the outside environment (Figure 1b–d). Housing with poor structural integrity also incorporated low quality, informal materials to patch up internal walls and ceiling holes; examples included cardboard, tarpaulin, and plastic wrap. The most prevalent structural issue was the evidence of water damage in 42% of houses (Table 1). The water damage in these houses was indicated by rotten wood, water staining on a ceiling and walls, peeling paint, rusted metal, damaged flooring, and the use of plastic sheets or buckets to capture residual water flow. In six houses, the sleeping areas were in rooms with holes in the ceiling or walls, and there was insufficient natural lighting so the sleeping area appeared dark during daylight hours (Figure 1d). In 32% of the houses, the windows were permanently boarded up with wood or the windows were damaged so that they no longer provided a physical barrier to the outside environment (Table 1). The cause of the damage observed in many houses was suggestive of high-velocity wind damage, particularly for those houses with missing corrugated roofing and a loss of windows. Houses where the damage was less extensive were likely to be due to the progressive degradation of low-quality building materials.

Figure 1. Range of house quality observed: (a) House without any evidence of structural damage and exterior is well maintained; (b) House surrounded by pools of rain water due to insufficient drainage, interior of house water damaged; (c) Poor building quality indicated by holes in the external wall and use of building materials to patch up exterior; (d) Children’s bedroom with damaged ceiling and walls, and evidence of water staining on the cardboard covering holes in the ceiling.

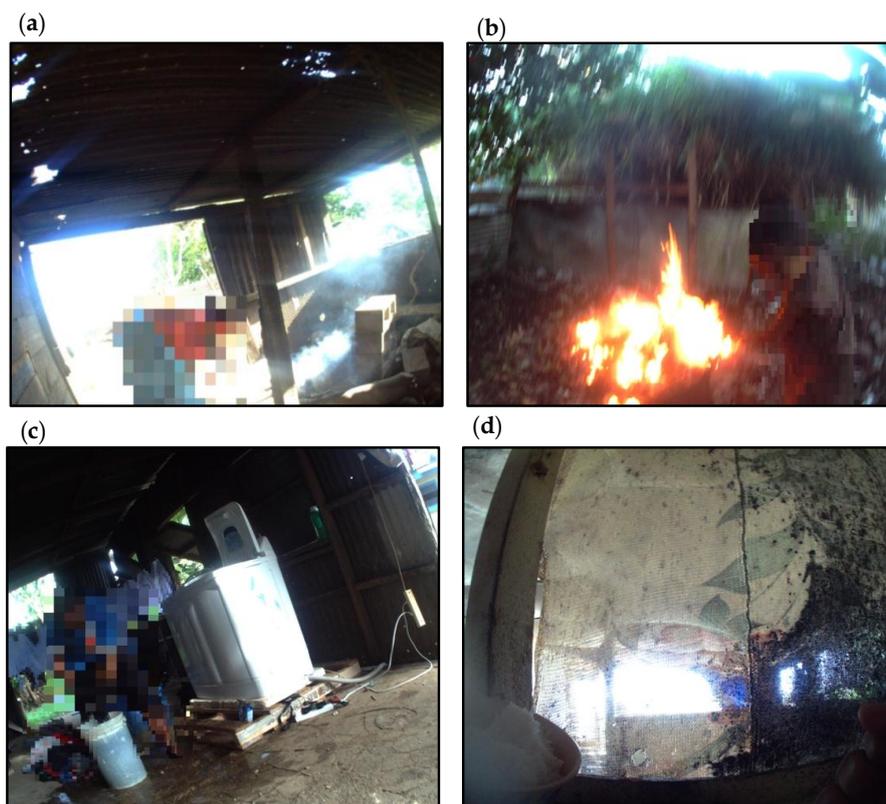
Nine houses did not have a formal kitchen, but had a separate cooking shed that was physically detached from the house (Table 1). The cooking sheds were more roughly constructed from rusted metal sheets and lumber. Seven of the nine cooking sheds identified had poor structural integrity, indicated by damaged walls and ceilings and evidence of water damage (Table 1). The sheds had limited storage and food preparation space, often contained large amounts of waste, and were easily accessible to dogs, pigs, or other animals kept around the home. Families spent a reasonably large proportion of their time in these cooking facilities throughout the day, sometimes spending more time in the cooking shed than the actual house. Families would prepare food in these sheds on the ground or in plastic buckets. If a gas cooker was not present, then some families cooked on an open solid fuel fire in the shed (Figure 2a). This was observed in 4% of households (Table 2).

Figure 2. Risk factors and behaviours observed in the home environment that increase the risk of injury or harm to children: (a) Cooking on an open fire in a cooking shed filled with smoke. Low-quality building materials used in structure; (b) Child burning rubbish and standing near flame; (c) Electrical extension blocks and power cables next to a washing machine and in the vicinity of a water spill; (d) Fabric covered in mould next to a food preparation surface.

Although electricity was widely used in the kitchen, only 13% of households had an electrical cooker (Table 3). Gas cookers were the predominant method of cooking, and these were used by 54% of homes (Table 3). Gas cookers require Liquefied Petroleum Gas (LPG) cylinders for fuel, and these were visibly present inside of 21% of houses (Table 2). The majority of gas cylinders were located in the cooking areas, but some were also observed in the sleeping areas and living areas. A few families had used an inventive solution to safely store the gas cylinder outside by running the gas hose through the external wall to the cooker (Figure S1). In 7% of homes, informal gas cookers were observed, specifically portable camping stoves or barbecues. These systems are not designed for indoor cooking, as they leak harmful gases and present a fire risk. In three homes, indoor cooking was observed with solid fuels (wood and coconuts), and the images contained evidence of smoke buildup in designated, enclosed cooking areas (Figure 2a).
